**CALIFORNIA REGIONAL WATER QUALITY CONTROL BOARD
SAN DIEGO REGION**

**PRELIMINARY
TECHNICAL ANALYSIS
SUPPORTING**

**ADMINISTRATIVE CIVIL LIABILITY
AGAINST**

**SAN DIEGO UNIFIED SCHOOL DISTRICT
FOR
FAILURE TO COMPLY
WITH**

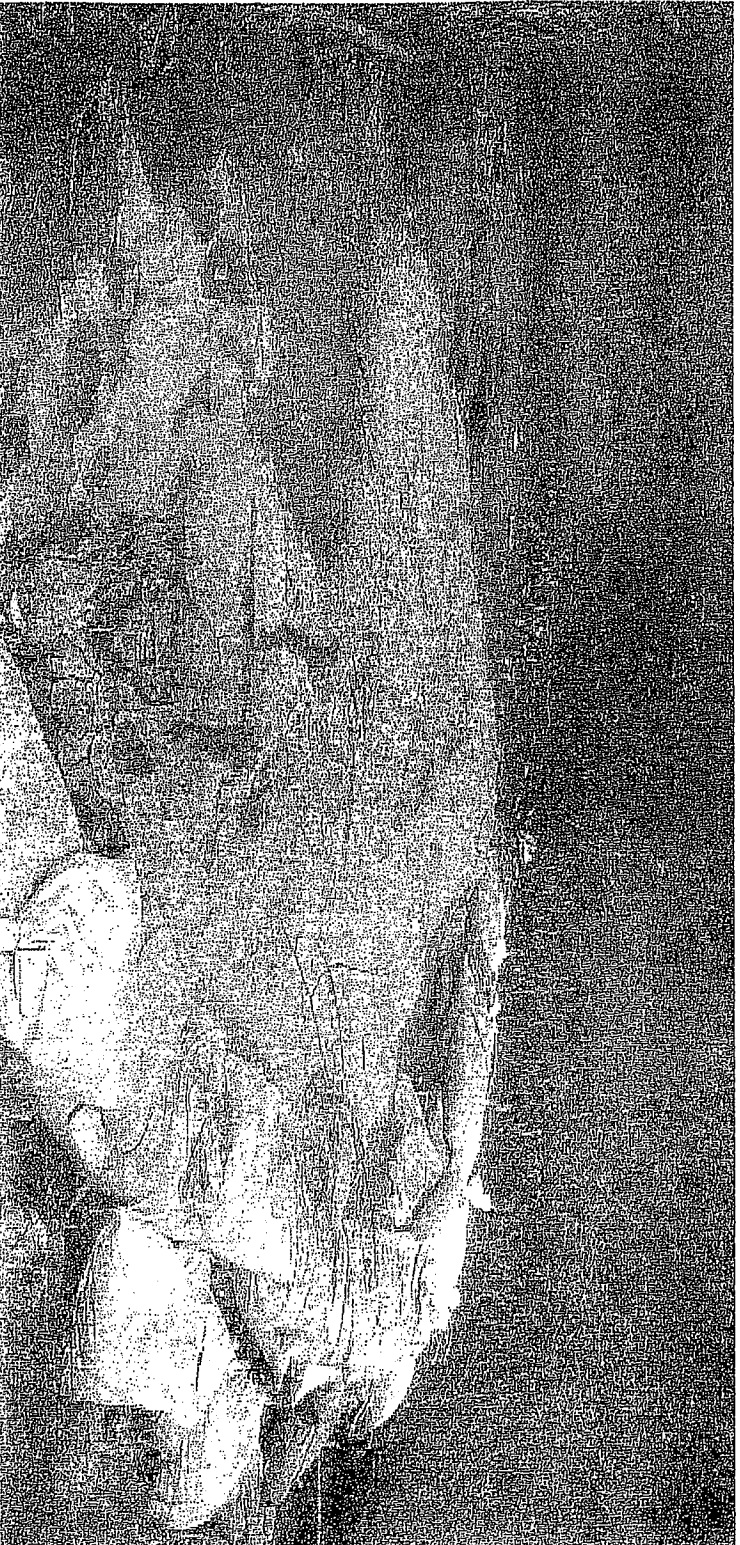
Image IMG P0685 WDID #9 37C329152;

Image shows: BMPs installed in the water of state. BMPs not maintained. Sediment discharged to Carrol Canyon downstream.

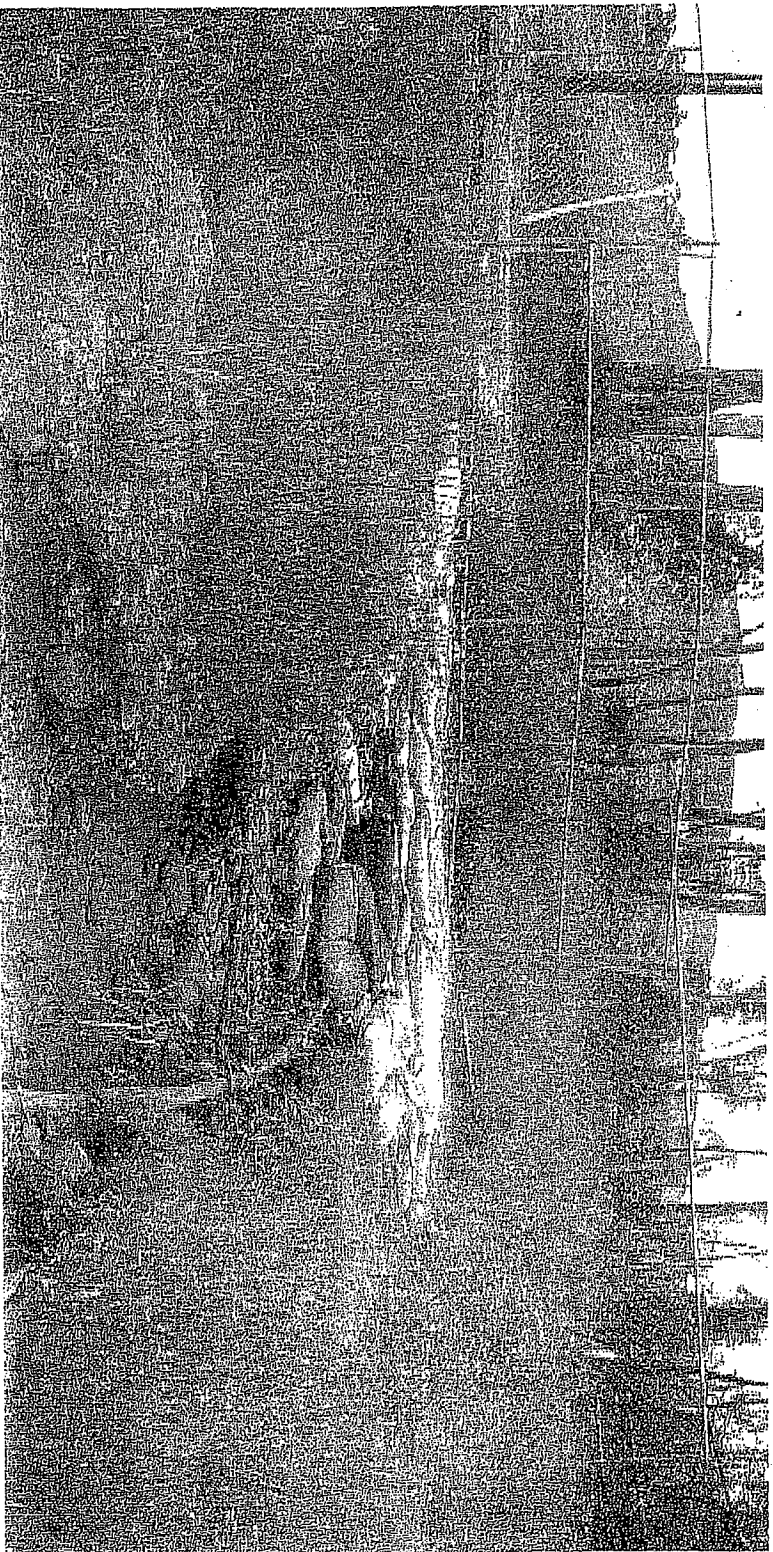
Image IMG P0688 WDID #9 37C329152;
Taken by Dat Quach, RWQCB-SD, between 1400 and 1500 on 03-18-2005

Image shows: BMPs installed in the water of state. BMPs not maintained. Sediment discharged to Carrol Canyon downstream.

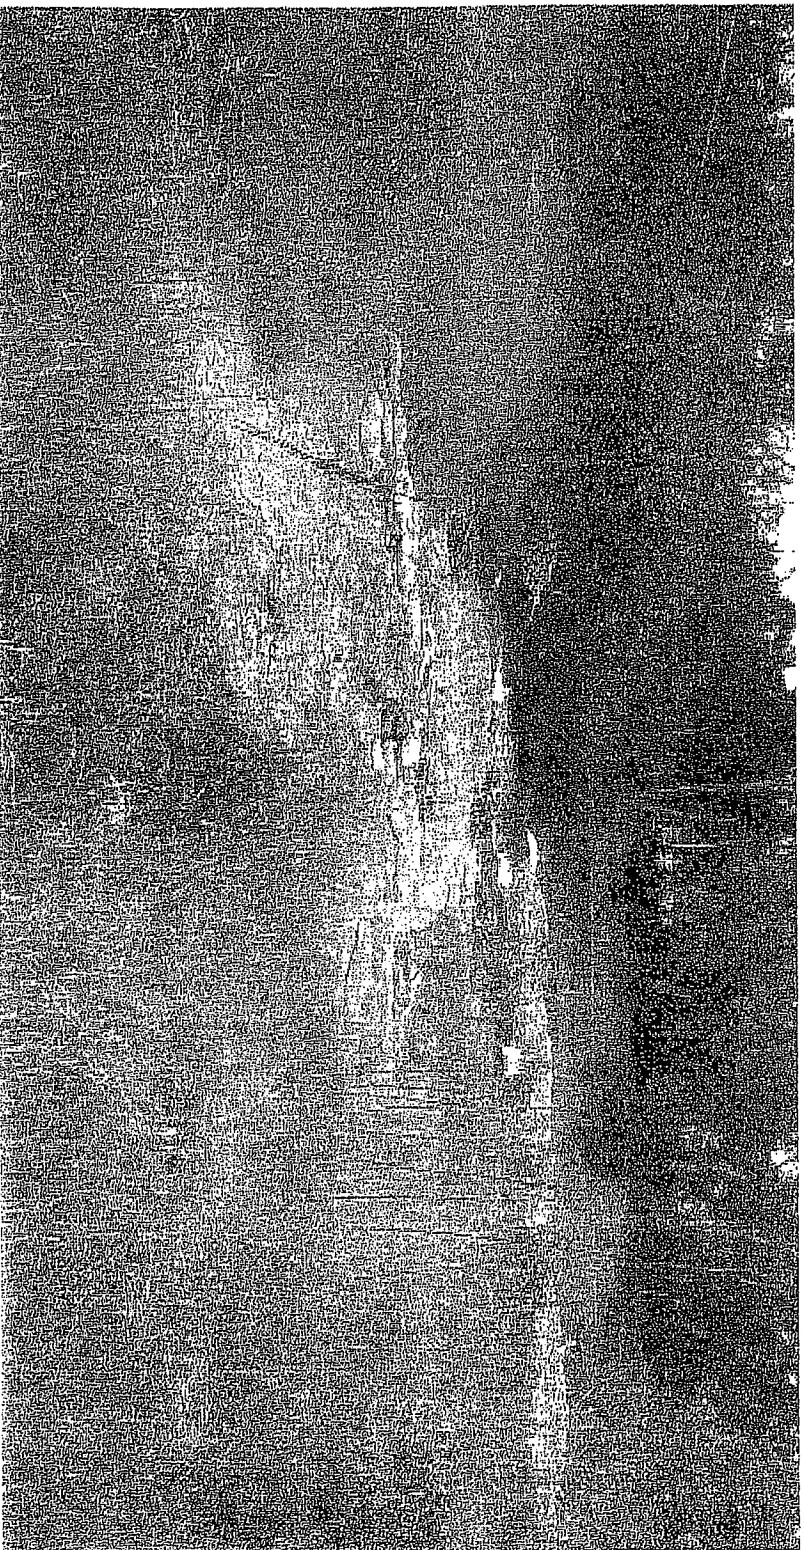
Image IMG P0690, WDID #9 37C329152;

Image shows: BMPs installed in the water of state. BMPs not maintained. Sediment discharged to Carrol Canyon downstream.

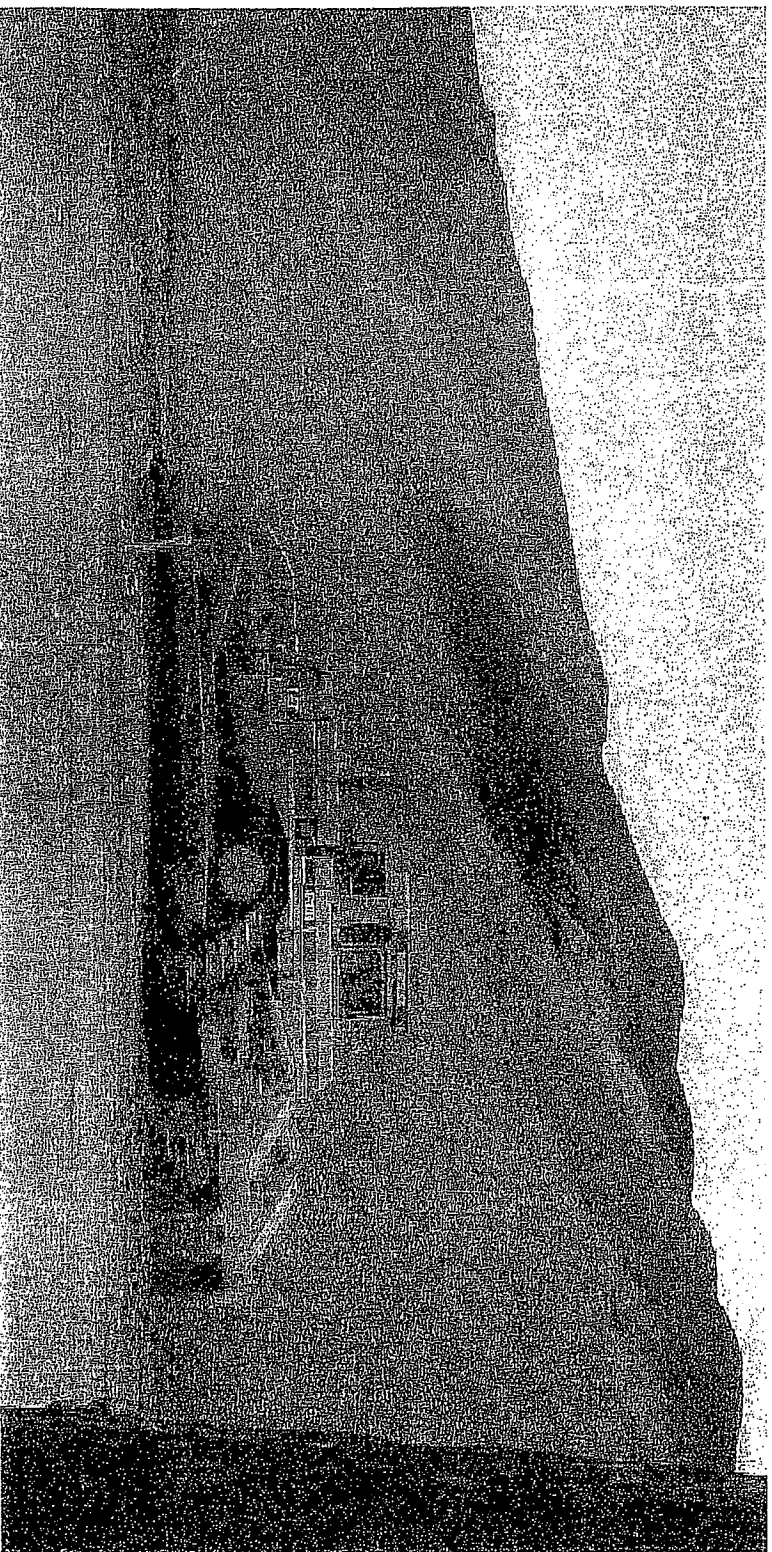
Image IMG P0693 WDID #9 37C329152;

Image shows: No BMPs for erosion and sediment control for mass grading and dirt piles when there was more than 50 percent of chances of rain.

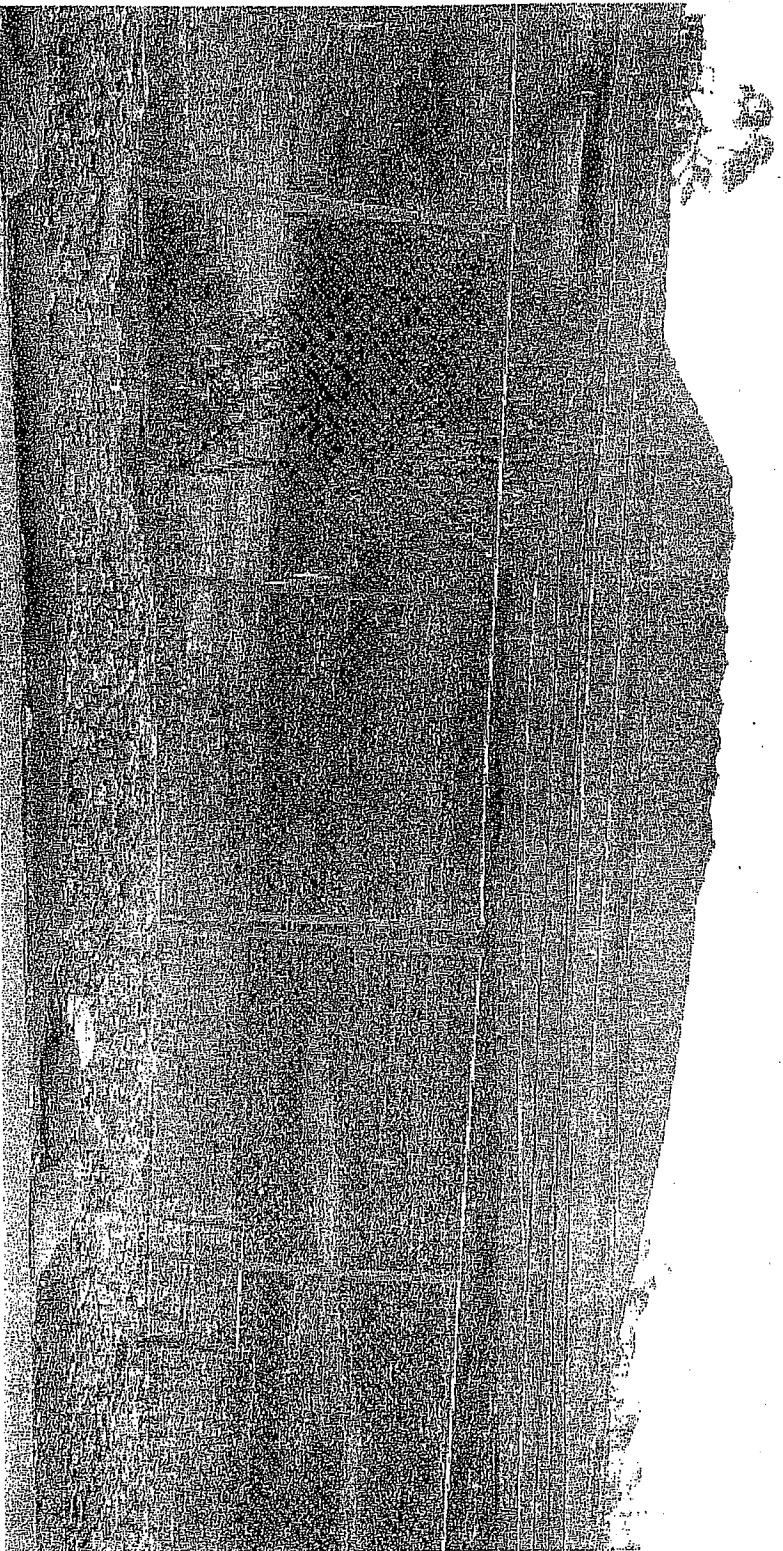
Image IMG P0696 WDID #9 37C329152;

Image shows: No BMPs for erosion and sediment control for mass grading and dirt piles when there was more than 50 percent of chances of rain.

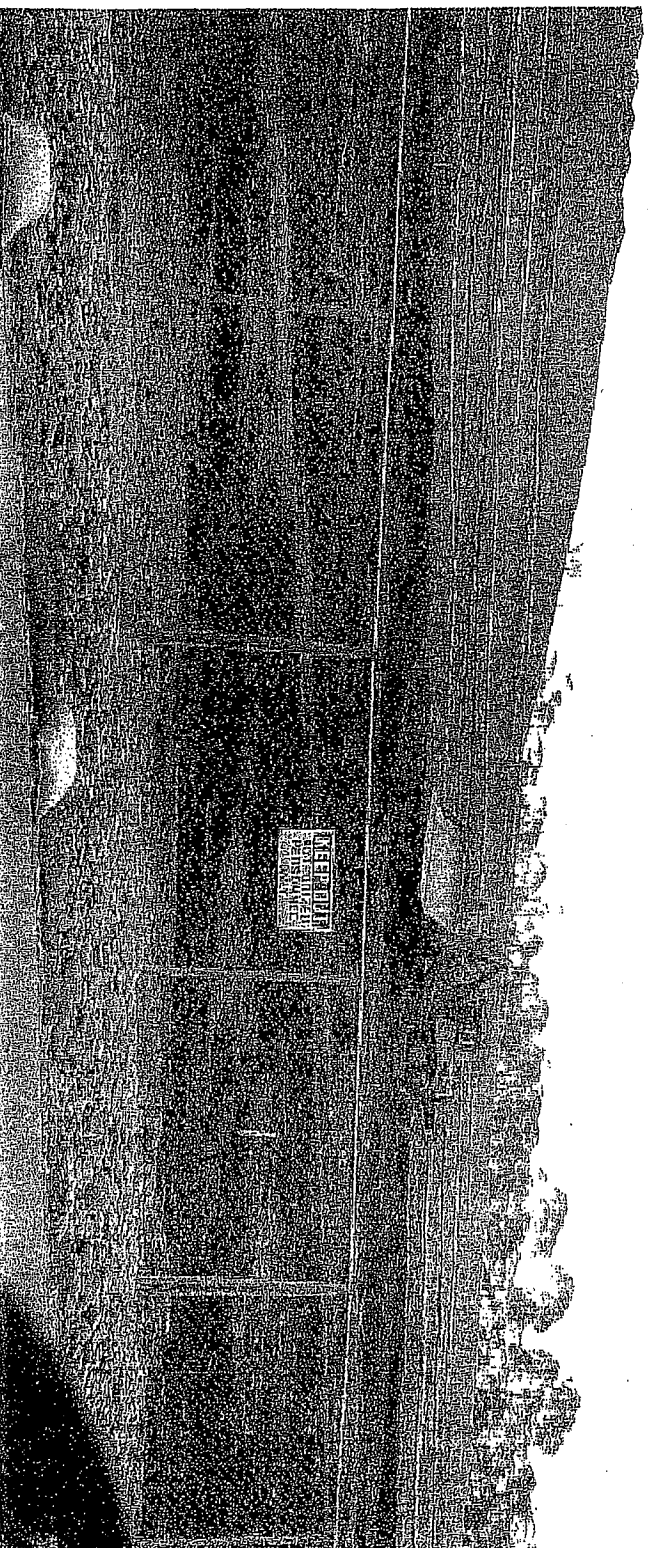
Image shows: No BMPs for erosion and sediment control for mass grading and dirt piles when there was more than 50 percent of chances of rain.

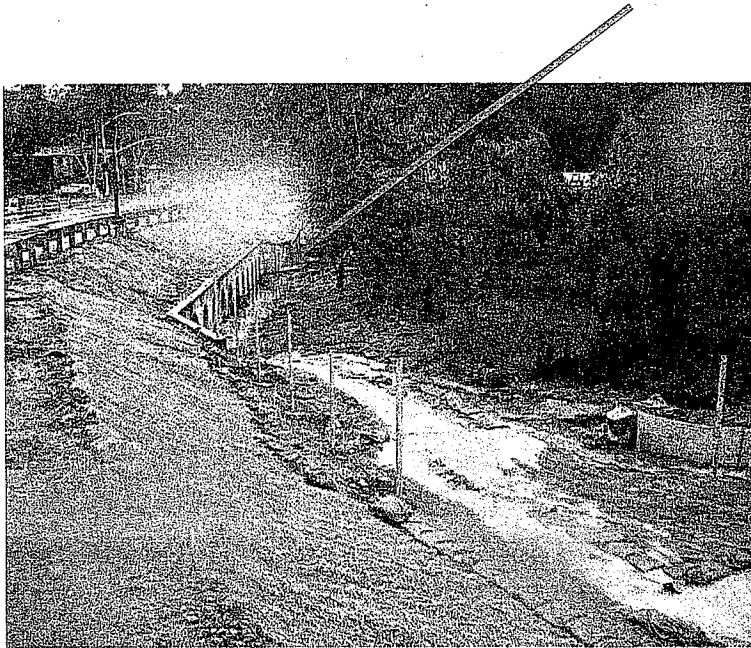
149. Sediment and sediment-laden water entering Carroll Canyon Creek. Arrow points to the culverts for Carroll Canyon Creek going under Avenue of Nations.

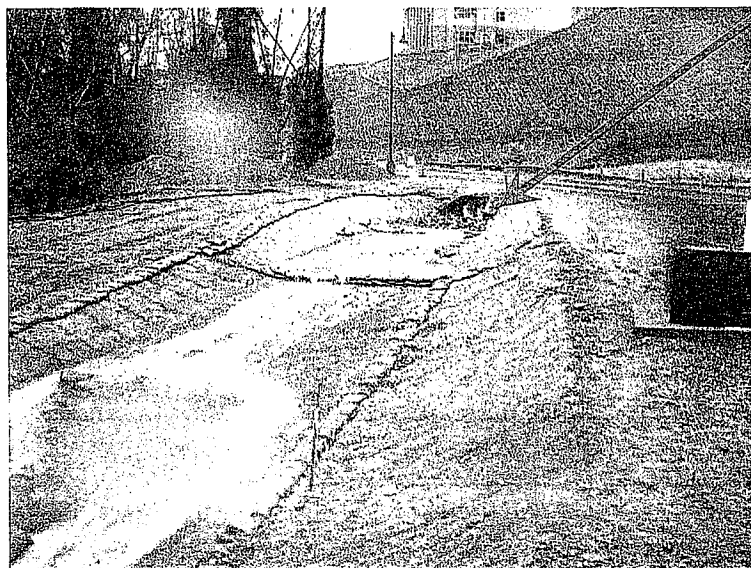
150. Photo is looking upstream of the discharge in photo 149. Sediment-laden runoff is flowing from a storm drain culvert outlet pointed out by the arrow.

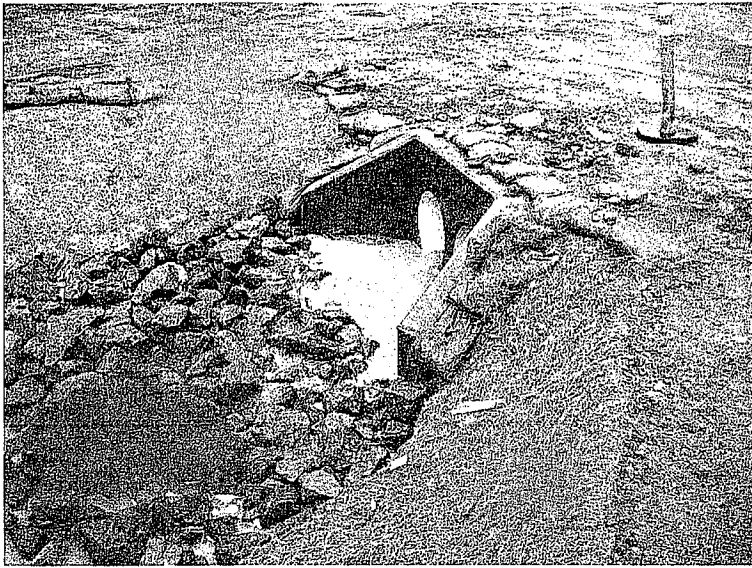
151. A closer look at the storm drain culvert discharging the sediment-laden runoff.

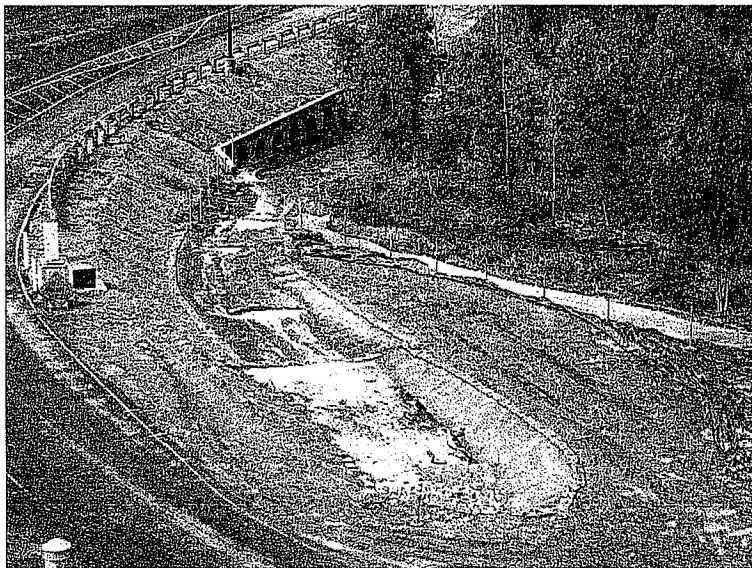
196. Photo taken later in the day after the rain has stopped. This photo was taken from above at the school site shows an overview of the discharge.

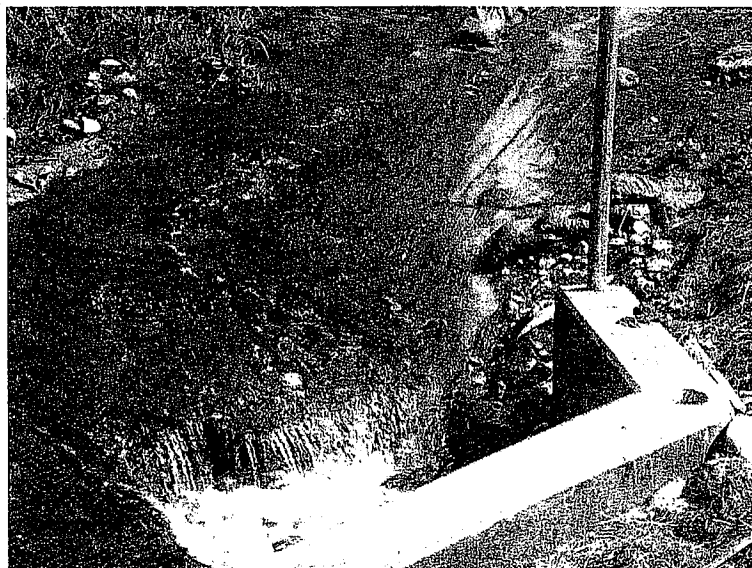
207. The point where the sediment-laden runoff enters the clean stream. This photo was taken after the rain has stopped and sediment-laden runoff flow rates were less than during the rainstorm.

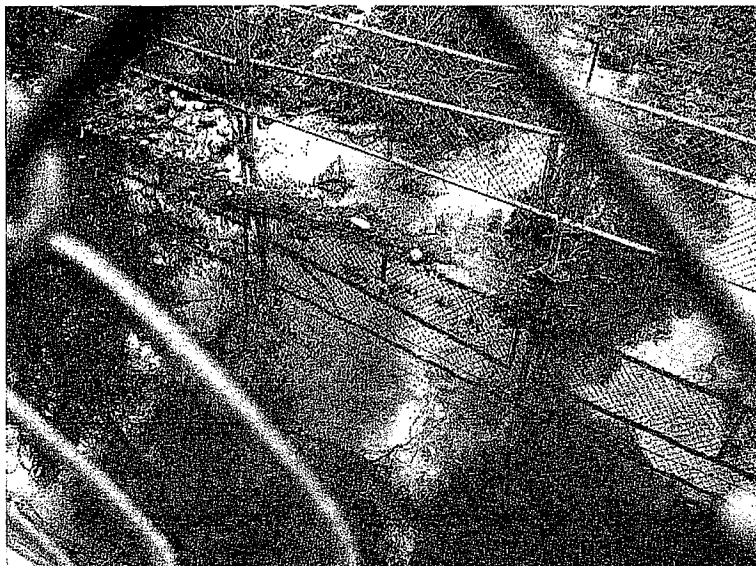
205. Downstream of the Avenue of Nations culverts crossing Carroll Canyon Creek, the creek water is very turbid along the south bank where the construction site discharges.

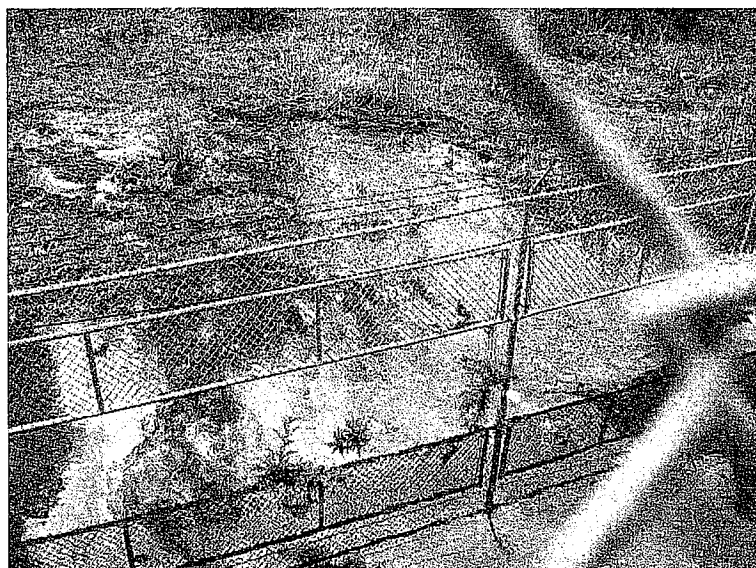
206. Downstream of the Avenue of Nations culverts crossing Carroll Canyon Creek, the creek water is clear along the northern bank not receiving construction site discharges.

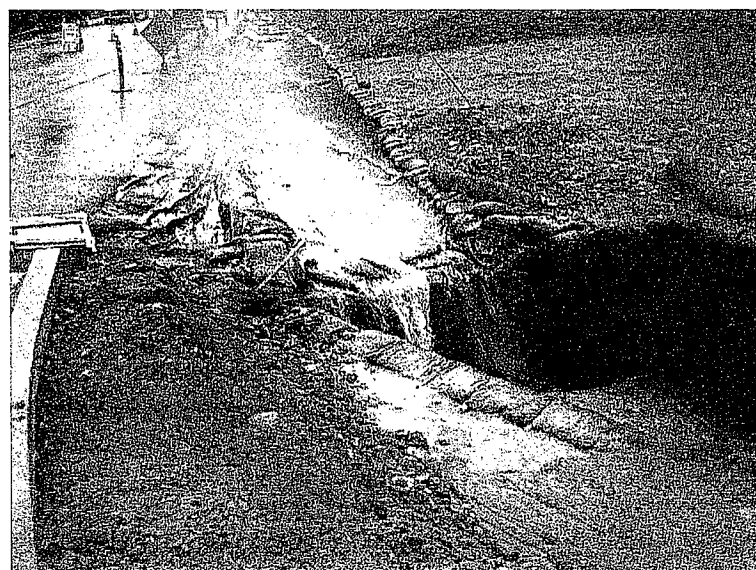
152. This is the culvert entrance to photo 151 on the south side of Avenue of Nations receiving sediment-laden runoff.

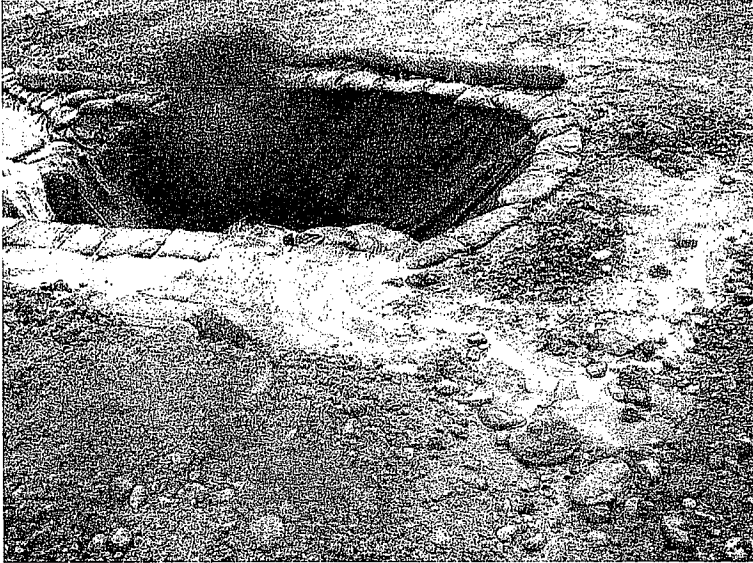
153. Another view of the culvert entrance on the south side of Avenue of Nations, shows sediment and sediment-laden water entering the storm drain culvert from another side.

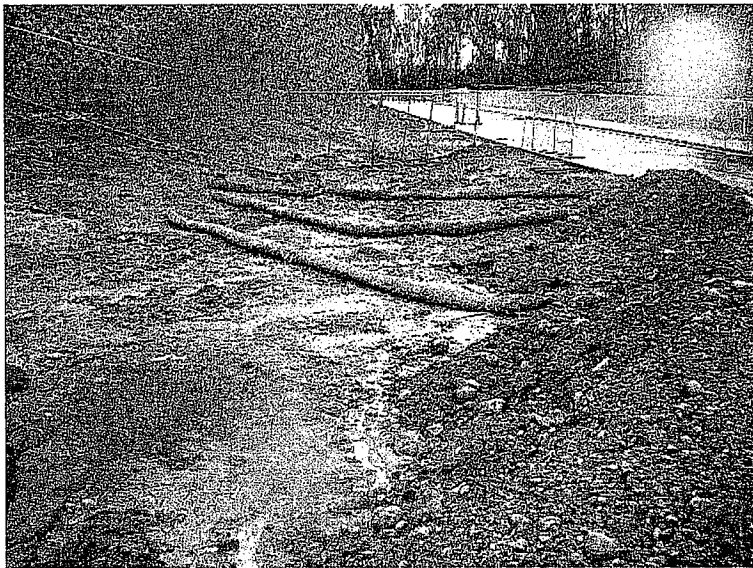
154. Upstream of the culvert entrance on the western side, no erosion controls have been implemented. Fiber rolls have not been trenched in and staked therefore they are doing little to stop the sediment flows.

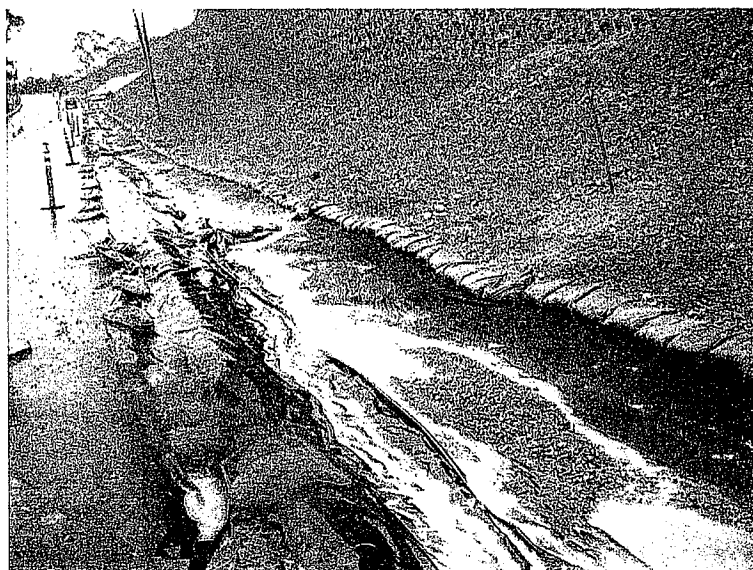
We traveled east on Avenue of Nations following the plastic lined ditch. The plastic lined ditch had sediment and sediment laden water flowing in it (Photo 157). At various points along the slope above the ditch, we saw slope failures and sediment laden runoff discharges to the plastic lined ditch (Photos 156 and 159). The plastic lined ditch ended at a storm drain outlet at the east end of the construction project (Photo 160). Joe Ciaccio, superintendent for Soltek Pacific, stopped on the street to speak with us. We told him that we would go meet with him at the construction trailer. We entered the school site but could not find the construction trailer. We walked around the school's front paved entrance. A storm drain inlet was overwhelmed with sediment and sediment-laden water at the paved entrance to the school (Photo 163). The medians in the parking lot did not have sediment controls on the perimeter and sediment-laden water was flowing off them (Photo 164). Sediment tracking was observed and no perimeter sediment controls were implemented behind the curb (Photo 166). Gasoline cans were stored outside without cover or containment to minimize exposure to storm water (Photo 167).

157. This plastic lined ditch is along the south side of the Avenue of Nations. The ditch terminates at the culvert in photo 153. Inadequate sediment controls along the face of the slope and the toe of the slope. Sediment laden water and sediment in the ditch.

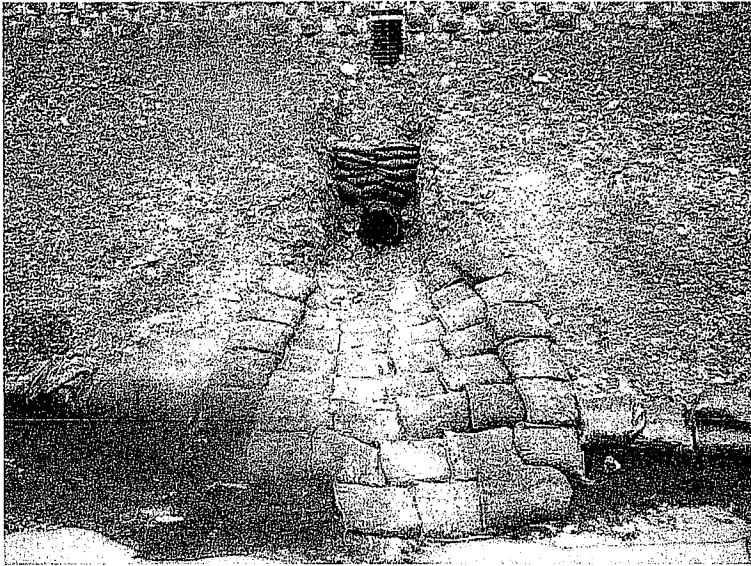
156. A runoff discharge point upstream to the east of the culvert in photo 153. Sediment-laden runoff flows out of the pipe across the gravel bags and into the plastic lined ditch.

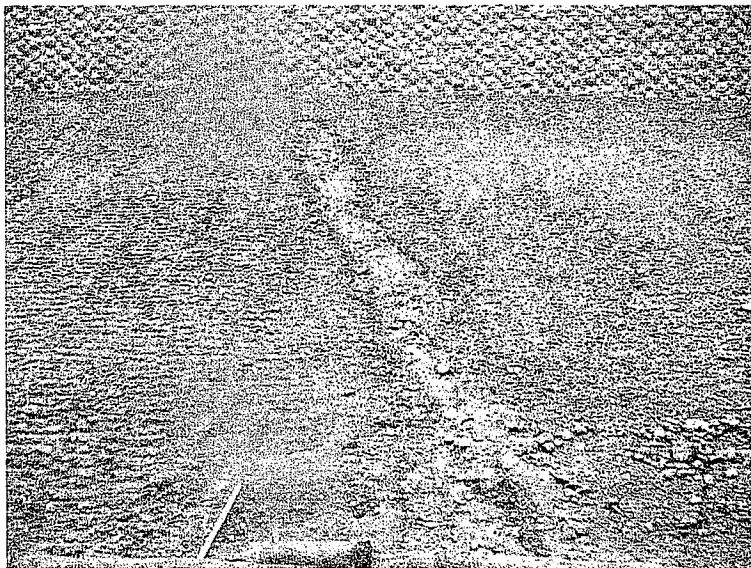
159. Slope failure is causing a discharge of sediment and sediment laden water. Slope face has no fiber rolls.

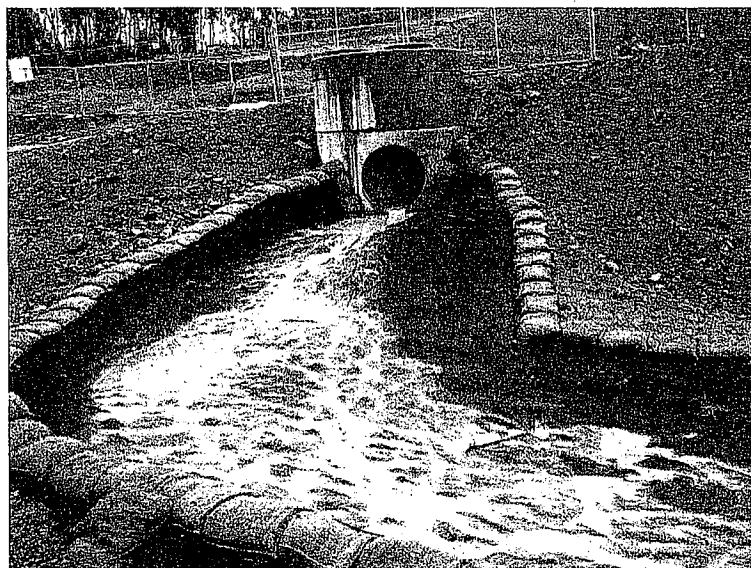
160. Storm drain outfall to the plastic lined ditch along the south side of Avenue of Nations.

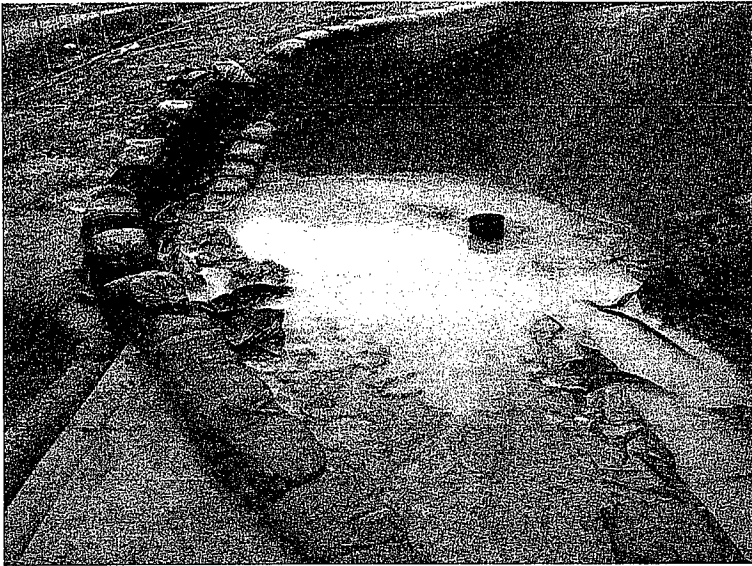
163. A storm drain inlet that goes to the discharge point in photo 160. The inlet is overwhelmed with sediment and sediment-laden water.

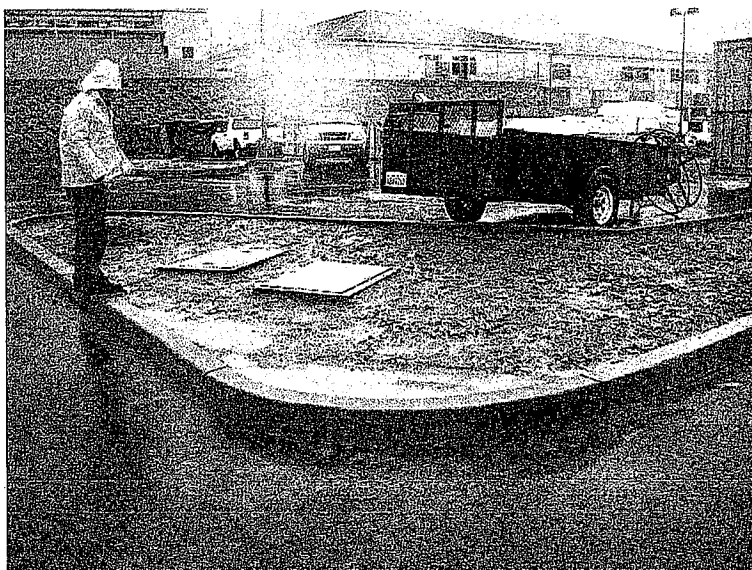
164. Medians in the school parking lot did not have any sediment controls.

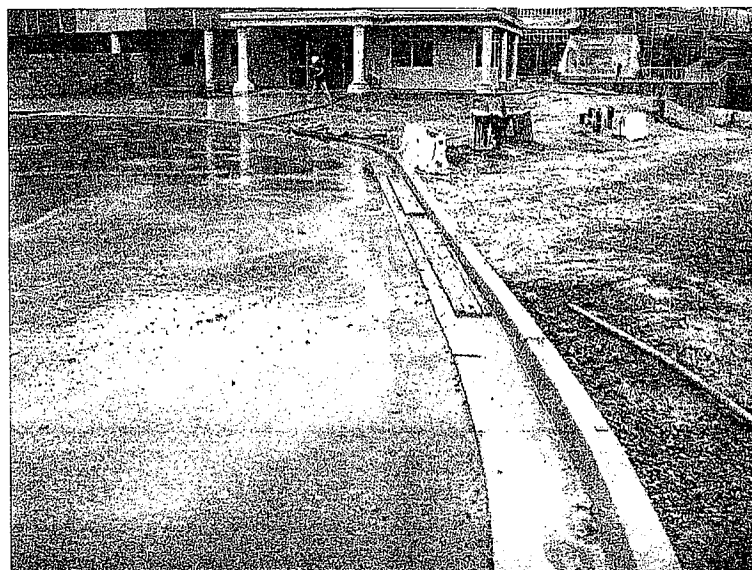
166. Sediment is tracked onto the street. No sediment controls have been implemented behind the curb.

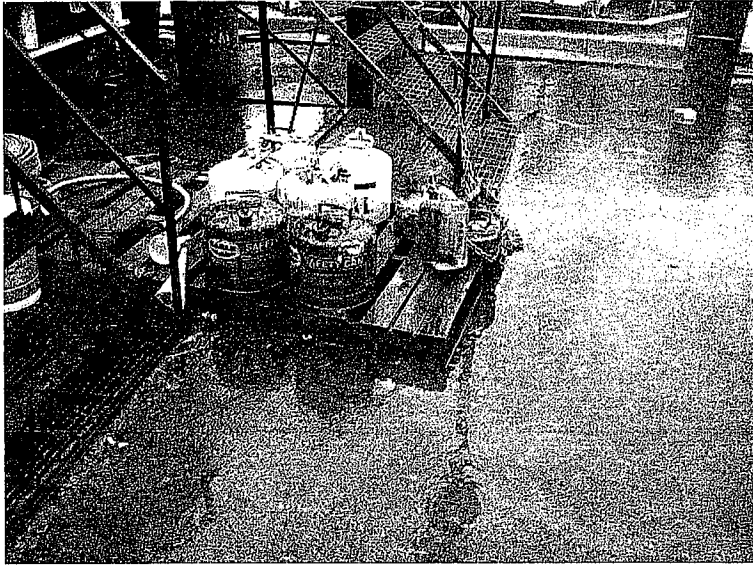
167. Gasoline storage has inadequate cover or containment to minimize storm water exposure.

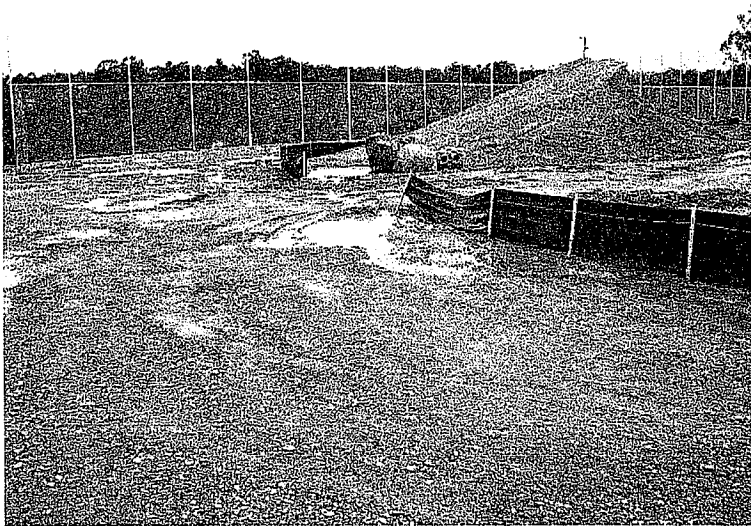
174. Silt fence around a stockpile is damaged and missing.

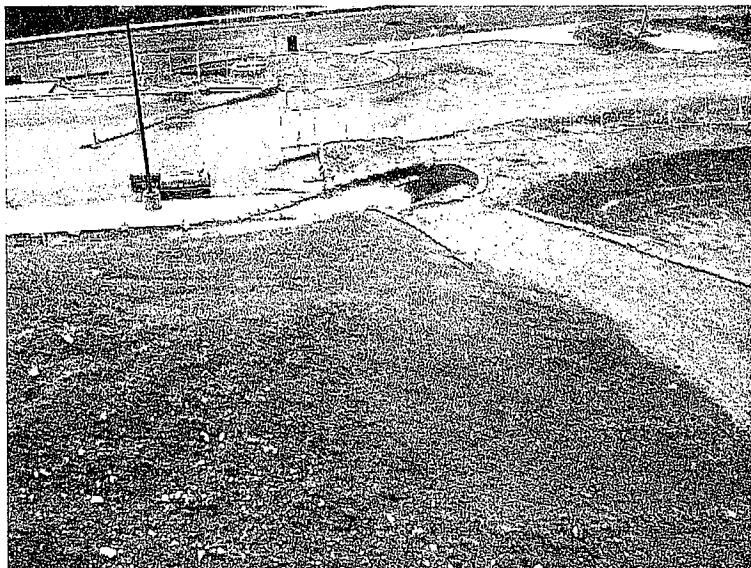
176. Looking downhill from the south towards the inlet in photo 163. Inadequate sediment and erosion controls are on the hill.

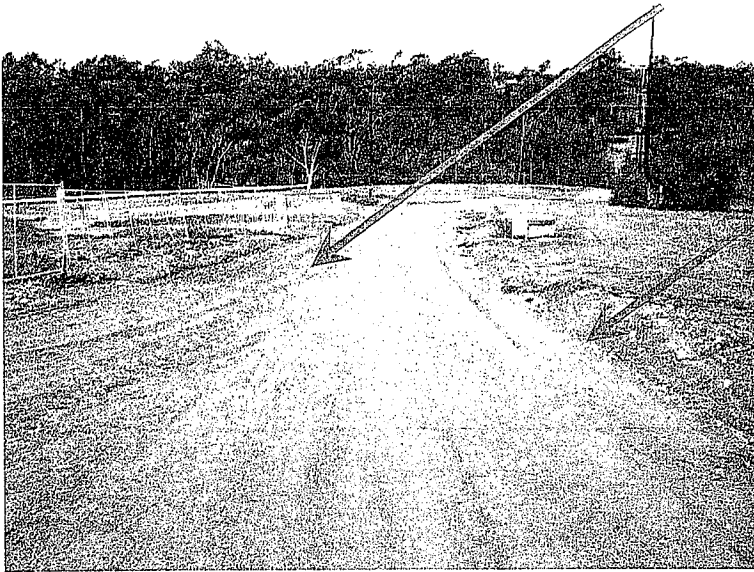
179. Farther uphill than photo 176, but also looking down towards the inlet in photo 163. The arrow points to 2 small rivulets of sediment-laden water running down the access road.

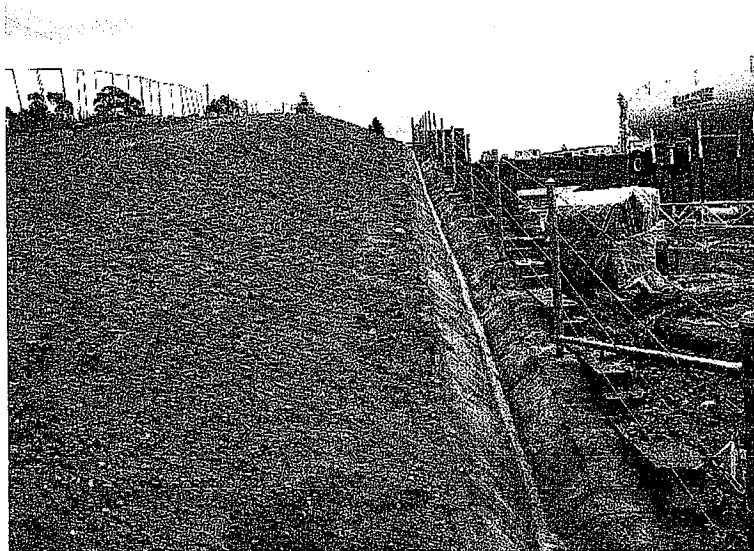
178. Upstream of the inlet in photo 177, the slope has no sediment controls along the toe of slope or in the concrete v-ditch.

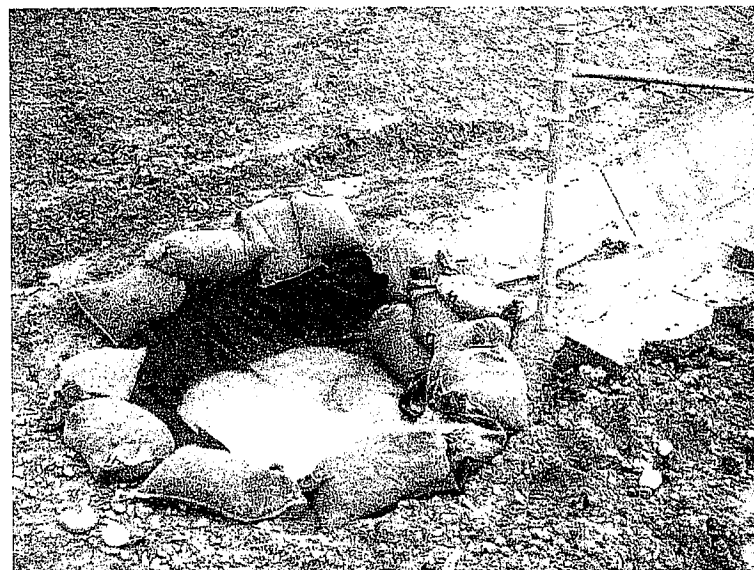
177. A storm drain inlet with sediment laden water.

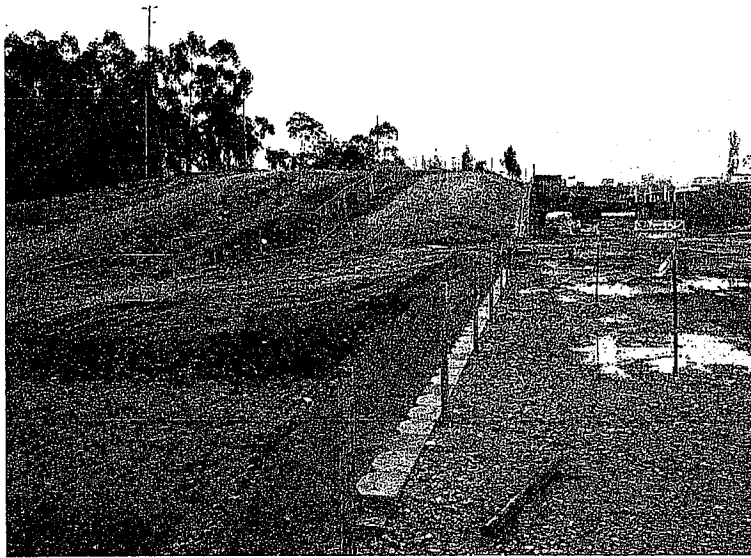
175. Looking uphill to the south from photo 179.

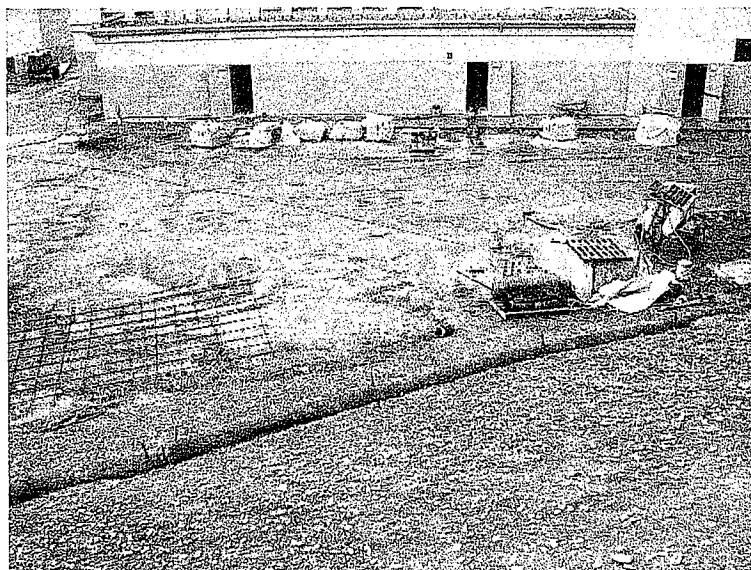
173. Material wash water spills are on the ground.

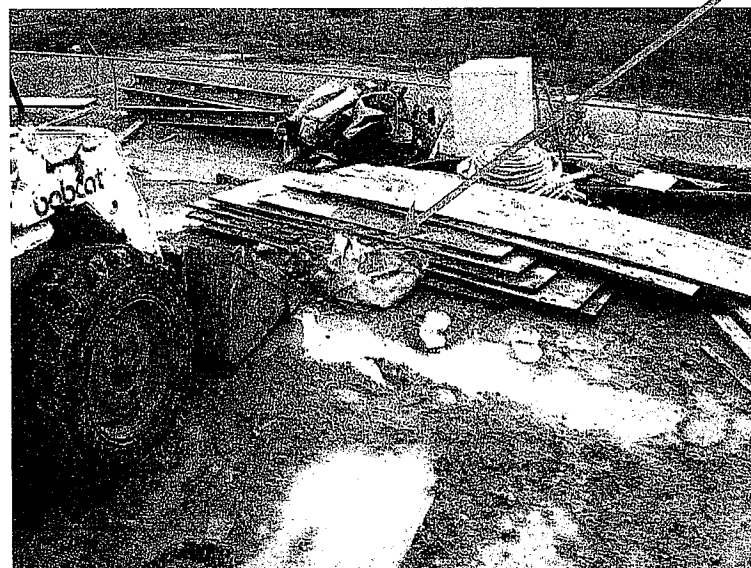
181. The arrow points to an open bag of concrete mix left out in the rain.

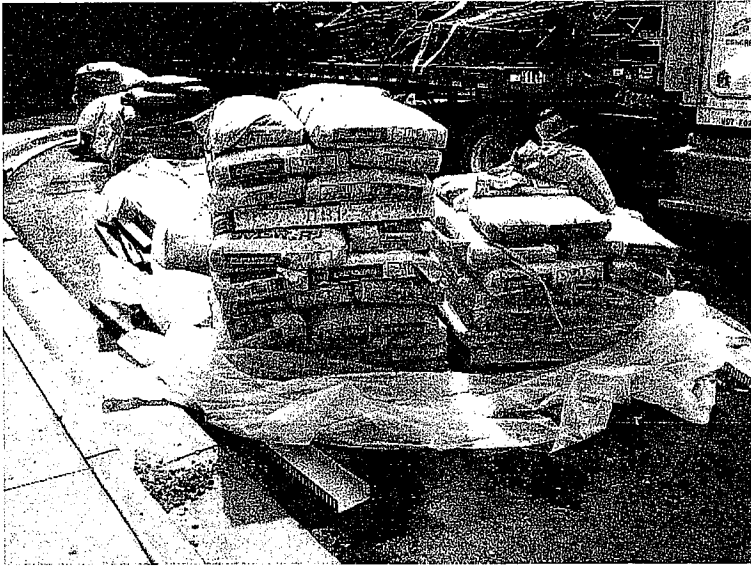
182. Bags of lime left out in the rain without cover.

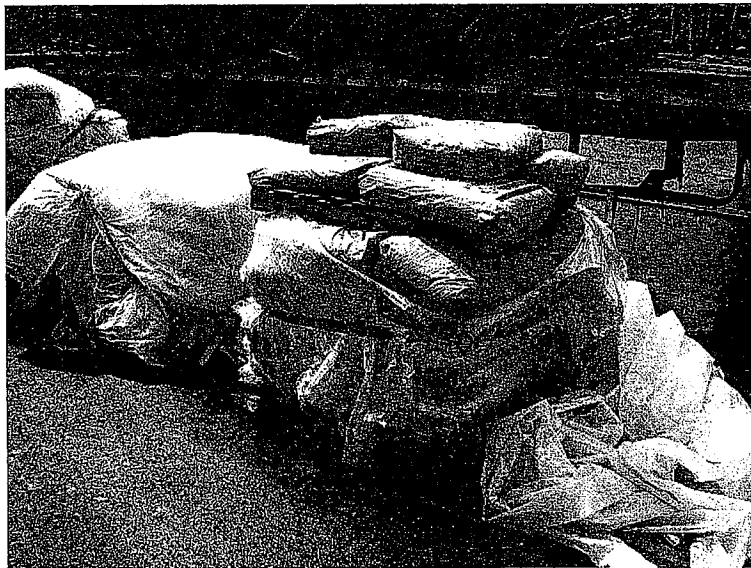
183. More material bags left out in the rain.

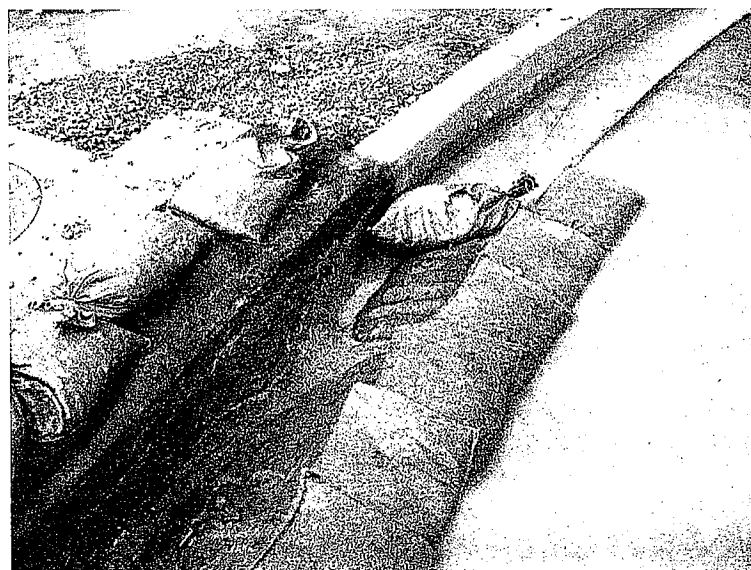
185. Sediment laden water entering a storm drain inlet with inadequate protection.

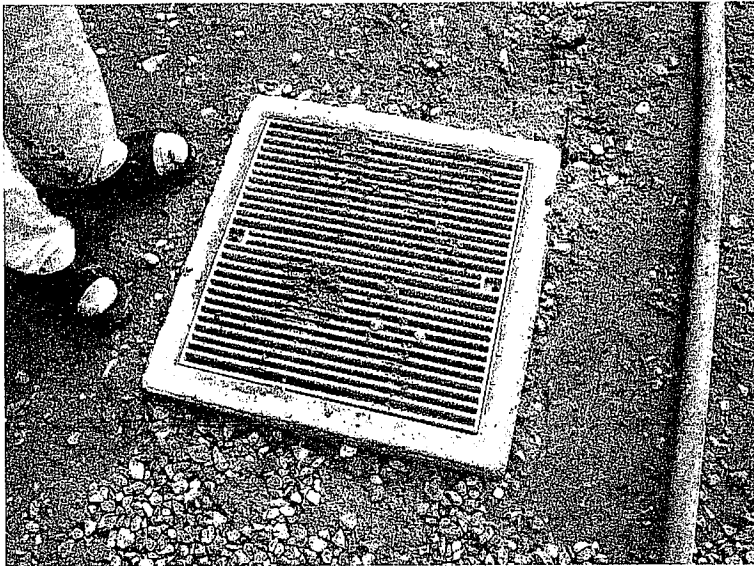
186. Storm drain inlet has no sediment protections.

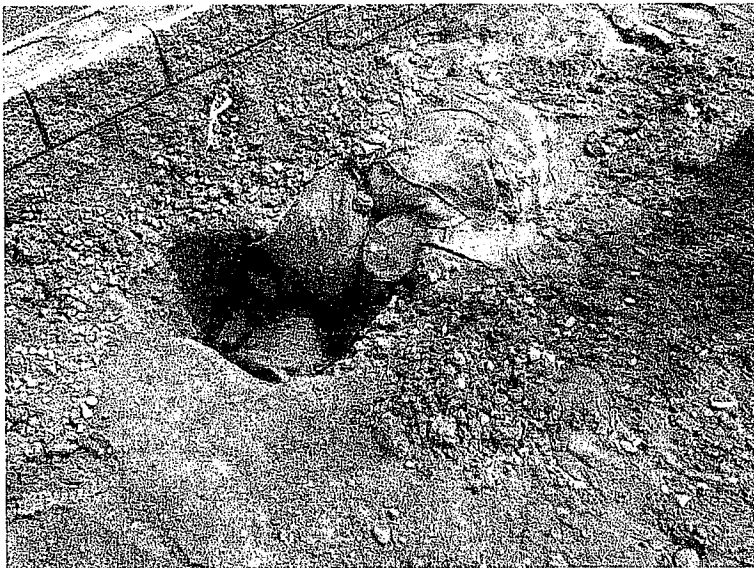
187. Storm drain inlet that is covered with filter fabric and gravel bags has been overwhelmed by sediment flows.

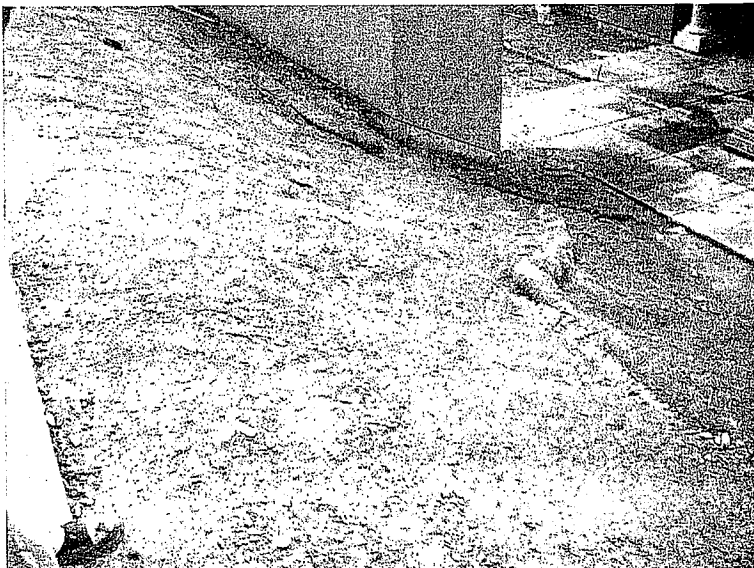
188. A slope with inadequate sediment controls. The fiber roll has failed. An erosion gully is running along the slope next to the wall.

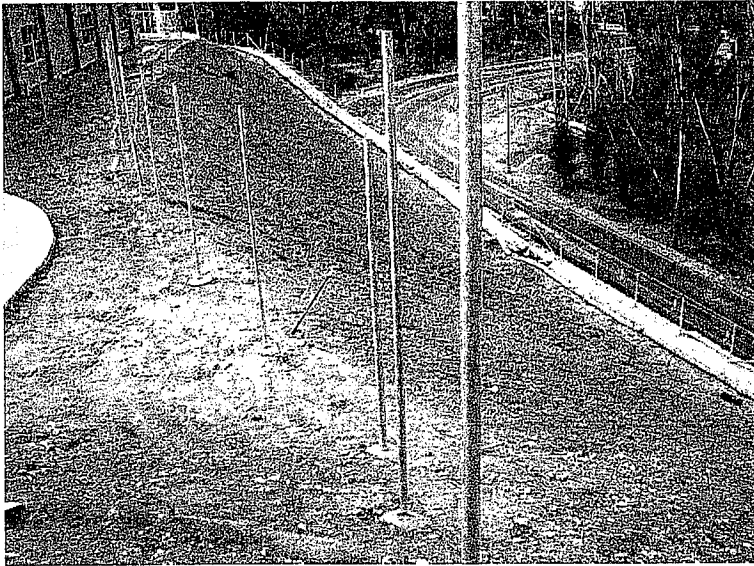
189. A large slope does not have fiber rolls along the face of the slope.
